TECHNICAL MEMORANDUM

NATURAL ENVIRONMENT AND WATER REPORT TERMS OF REFERENCE CONCORDANCE CROSS-CHECK - PROPOSED CBM ABERFOYLE SOUTH LAKE PIT

CBM ABERFOYLE SOUTH LAKE PIT– FISH COMMUNITY ASSESSMENT

FLOOD MAPPING – PROPOSED ABERFOYLE SOUTH LAKE PIT

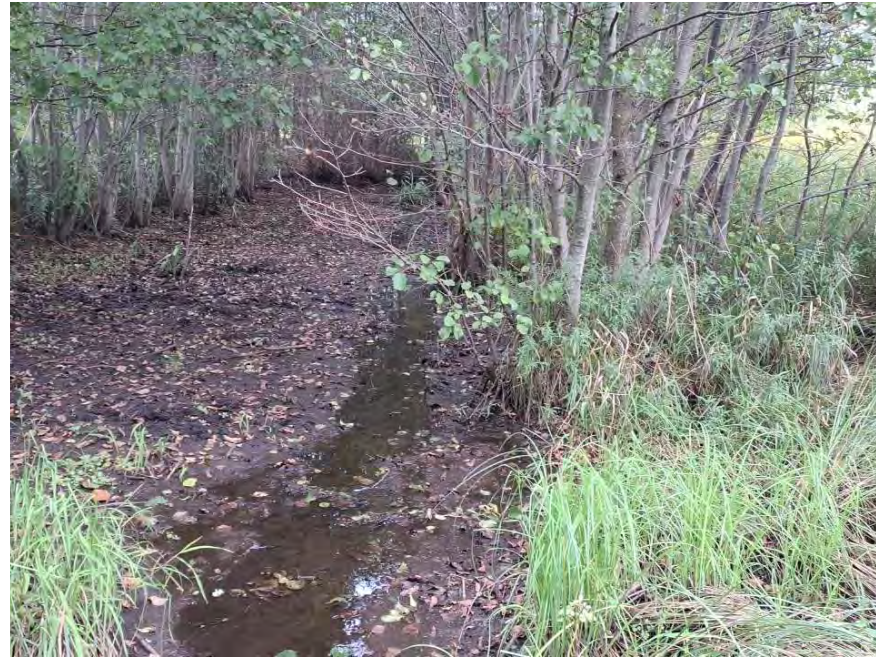
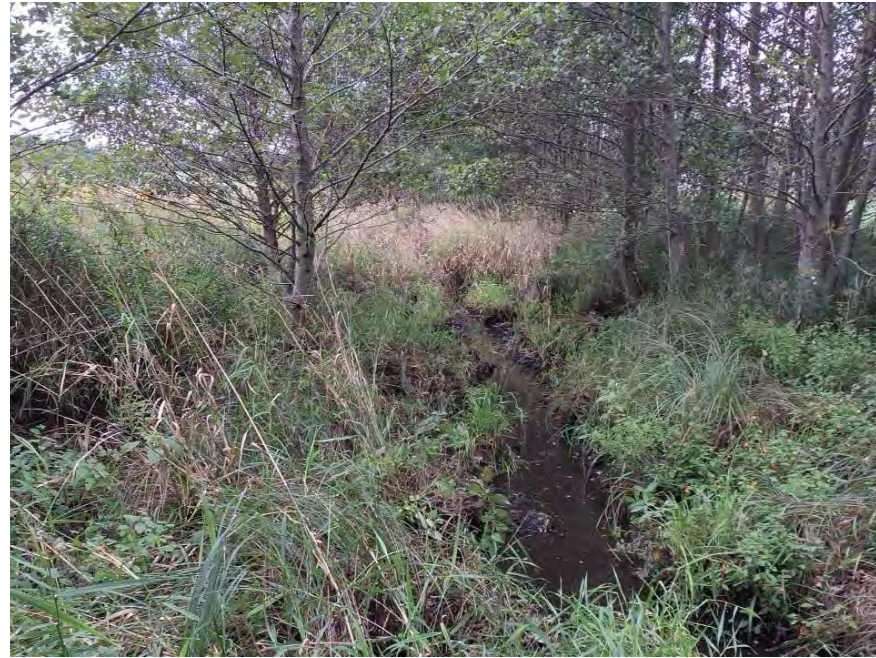
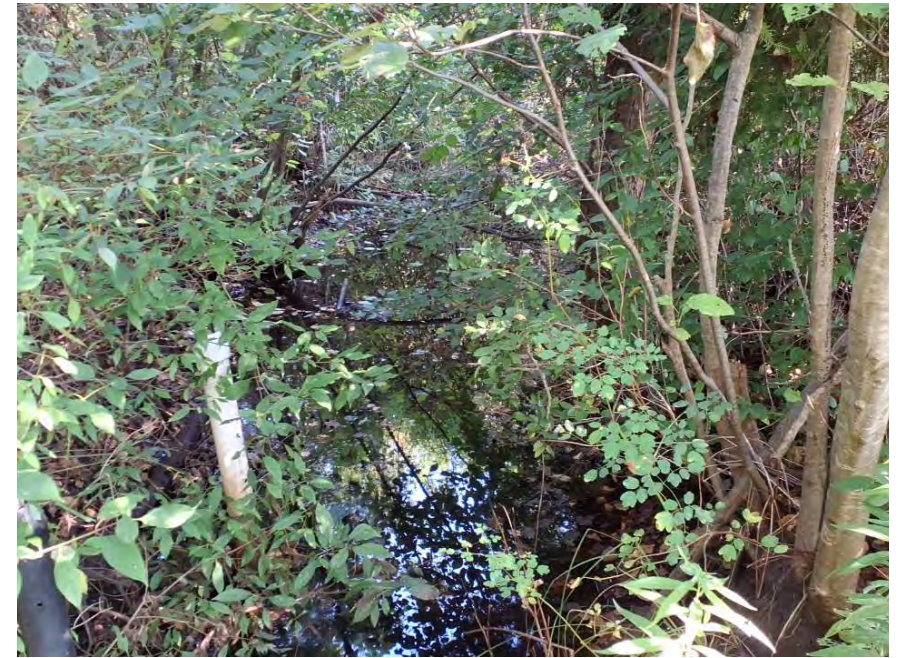
Photo 7. Tributary #3 (September 2024)

Photo 8. Tributary #3 (September 2024)

Photo 9. Tributary #3 (September 2024)

During the September 2024 survey, it was noted that the average wetted depth was less than 0.3 m with deep organic muck sections present through the middle reach of Tributary #3 (APPENDIX B). The presence of watercress indicates that the tributary is likely groundwater-fed (O’Neil and Hildebrand 1986 and WSP 2024). No specialized habitats (e.g., spawning) were identified in Tributary #3.
